## Advantest R3132 Local oscillator 3840MHz (2e Mixer) problem

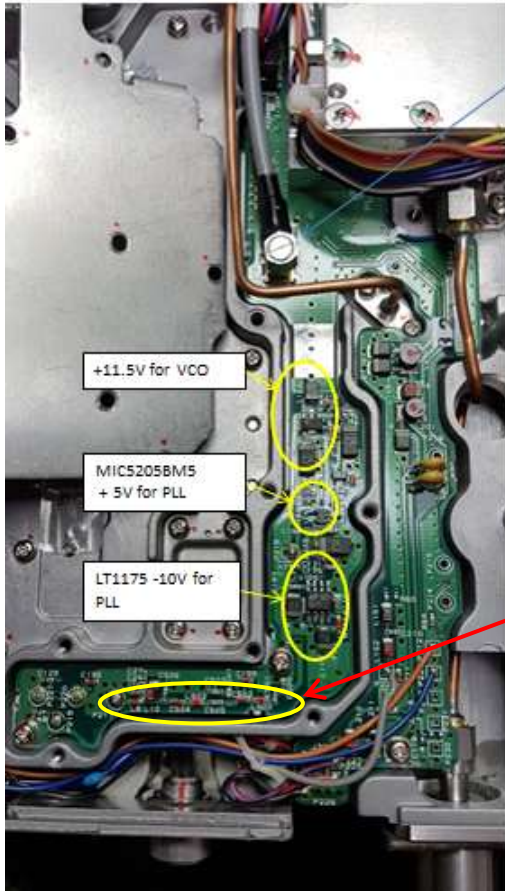
Figure 2: TOP side of PLL with feedthrough caps, and local power supplies

When you remove the controller board and the metal cover plate on the back of the PLL You will find the local power supplies for the VCO and the PLL and also the coaxial cable that delivers a 200MHz reference clock for the PLL.

*Note that the local power supply can be switched on and off by software.*

The power is fed to the PLL on feedthrough capacitors. The 200MHz reference frequency is capacitive coupled on the +11.5V by a filter network. *Not expecting this one!*

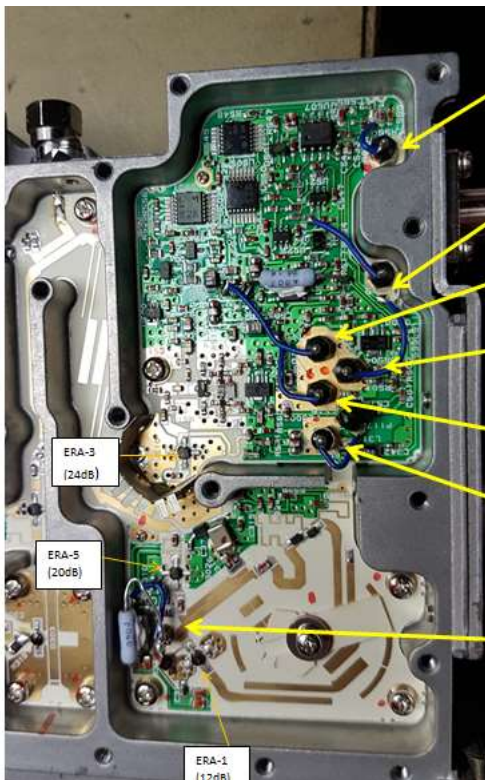
Figure 3: Open PLL and Oscillator

The complete PLL circuit is in this box. Only the power and 200MHz reference frequency are needed. The VCO tuning voltage feedthrough is an output that is routed back to the controller board, probably for monitoring.

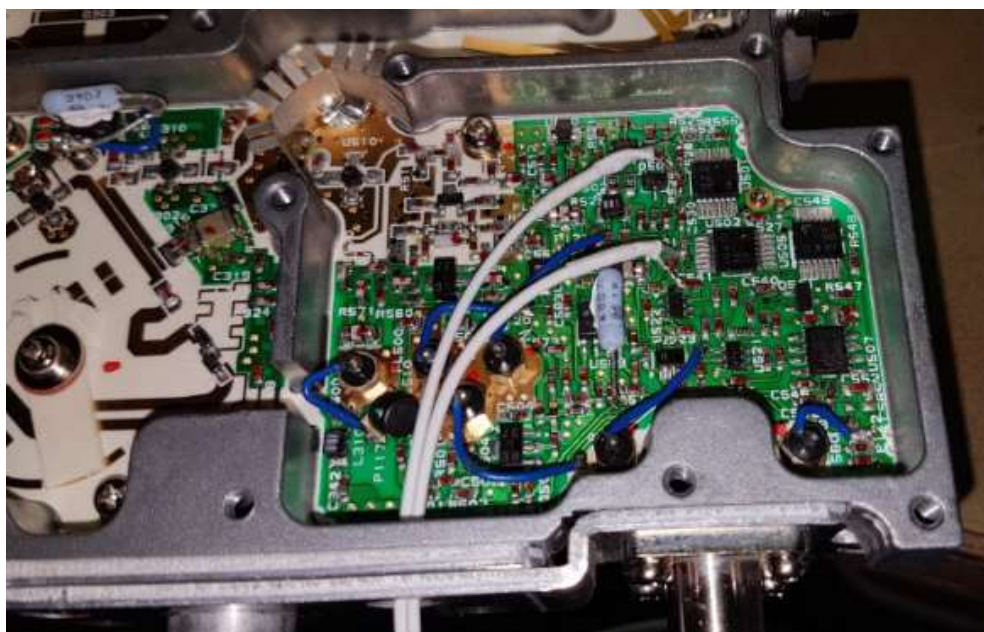
Figure 5: Measurement of phase detector input using thin coax (40Mhz top, 20MHz reference bottom)

Now that I knew where to measure I started with comparing the two clock signals for the PLL (Figure 5) And I noticed that the amplitude of the down mixed VCO signal fades away into the noise after a couple of minutes and it takes up to an hour or so of power-down before it resumes operation.

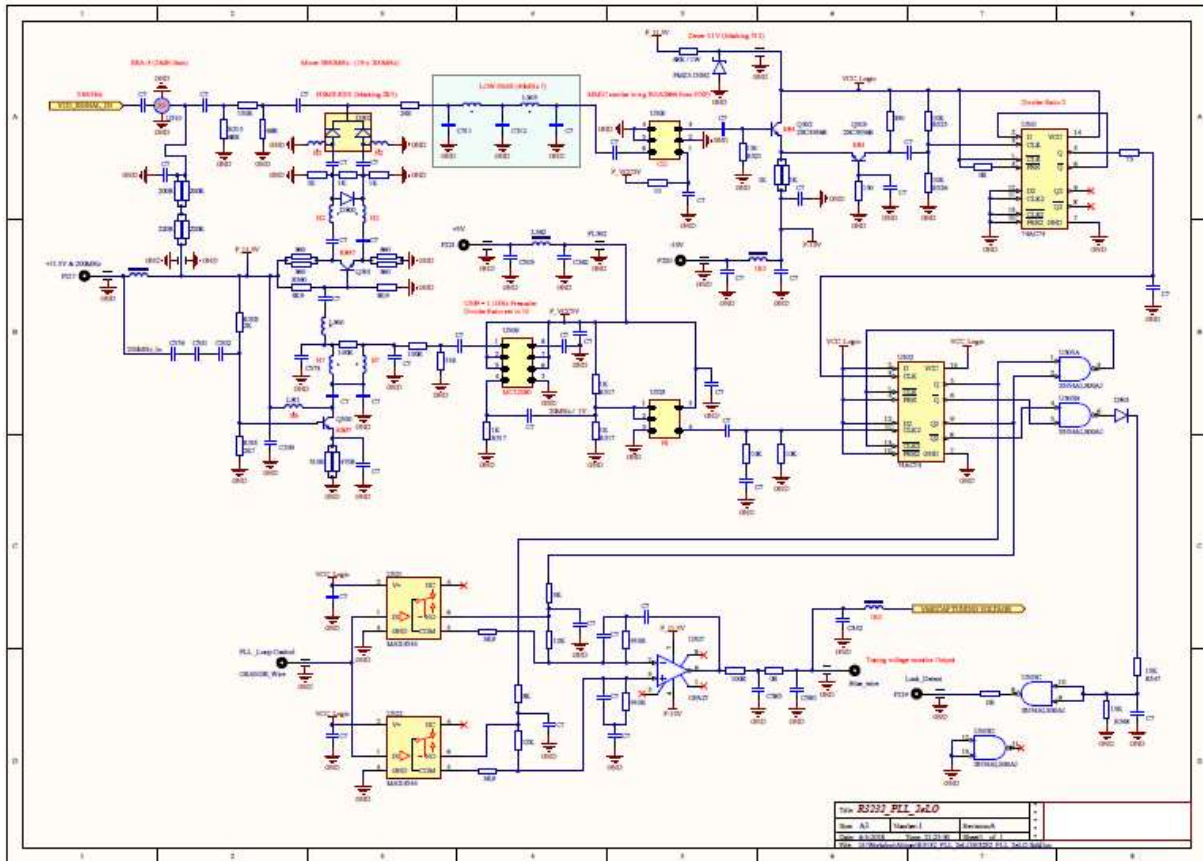
Figure 6: Reversed engineered circuit of the PLL

The 200MHz clock signal is extracted from the power supply and amplified by Q500. The output is fed to a PECL divider U509 and divided by 10 to generating a 20MHz reference for the PLL. The 200Mhz is also amplified and send to an harmonic generator Q501 and D500.

The VCO signal is amplified by an ERA-3 MMIC and mixed with the harmonics by D501. The 19e harmonic of 200MHz is 3800Mhz, the difference is 40Mhz.

The output of the mixer is send through a 40MHz Low-pass and amplified by U500. (U500 is an unknown MMIC that could possibly be replaced by a device from the BGA286x family of NXP.)

The amplified 40Mhz signal is divided by 2 by U501 (74AC74 flip-flop).

A second flipf-flop (U502) and the 2-input NAND-gate U505A forming the phase comparator. The outputs are connected to the Op-Amp OPA27. The output of this integrator / filter is fed to the varicap diodes of the VCO.

The loop time constant of the PLL can be changed by opening or closing the analog switches U521 – U522.

A Lock-Detect output is made with D501, an RC network and U505B and U505C

**Note:** *When the VCO is mistuned then it could lock to a different harmonic of 200Mhz, e.g. the 18e or 20e . This might result in a stable locked VCO but at a wrong frequency. I remember someone struggling with this problem.*

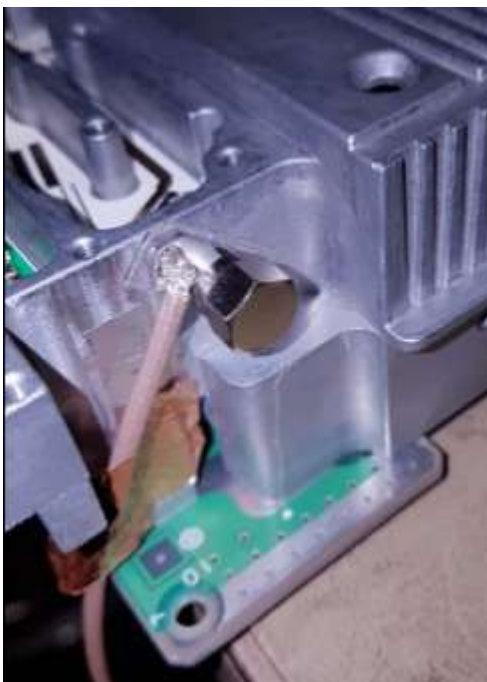
**Figure 7: Coax entering the unit**

I removed one of the screws of the SMA plug and pulled the coax shield in the hole. I wedged it with the tip of a tooth stick (pls don't laugh).

I fixated the cable to the frame at several places and lead it to the back of the unit.

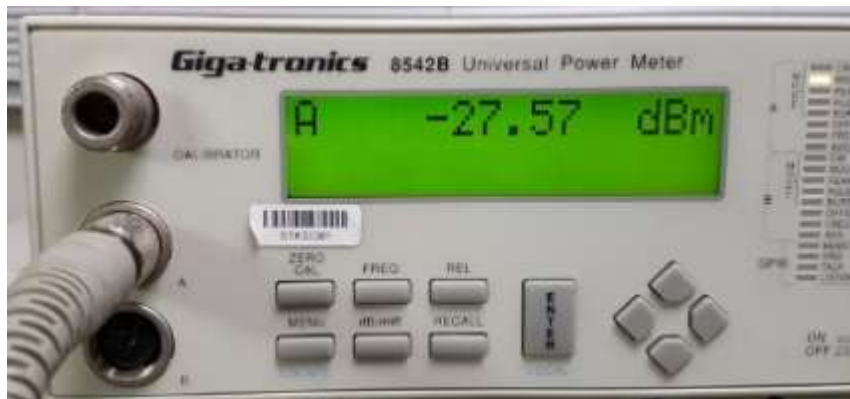
Figure 10: 3.84GHz output cold start (note that this is almost 10dB lower then what other guys have measured)

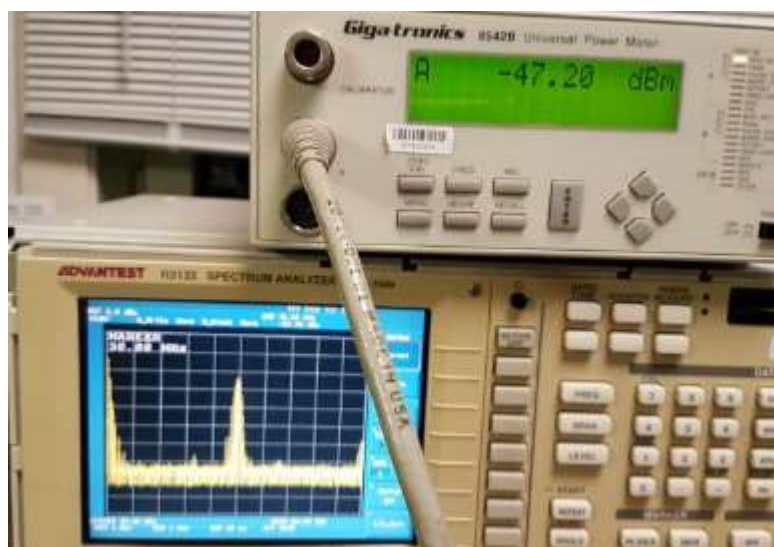
Figure 11: measurements after 7min On

Time minutes	dBm@3.84GHz	dBm measured @ 30MHz	PLL Lock
0	-26,81	-21,19	OK
1	-27,66	-21,32	OK
2	-28,35	-21,59	OK
3	-29,47	-21,7	OK
4	-30,74	-22,6	OK
5	-33,26	-24,4	OK
6	-36	-52	OOL
7	-47,2	-76	OOL

After these measurements it was clear that the VCO output level having thermal issues . My money is on the buffer MMIC (ERA-5) as culprit. I have ordered some devices now to replace the MMIC's in the VCO (I found the MMIC's here [www.funkamateur.de](http://www.funkamateur.de)).
